TECHNICAL INSPECTION REPORT
CONFIDENTIAL

U.S. S. SALT LAKE CITY (CCA 25)

VOLUME 2 OF 2

OPERATION CROSSROADS

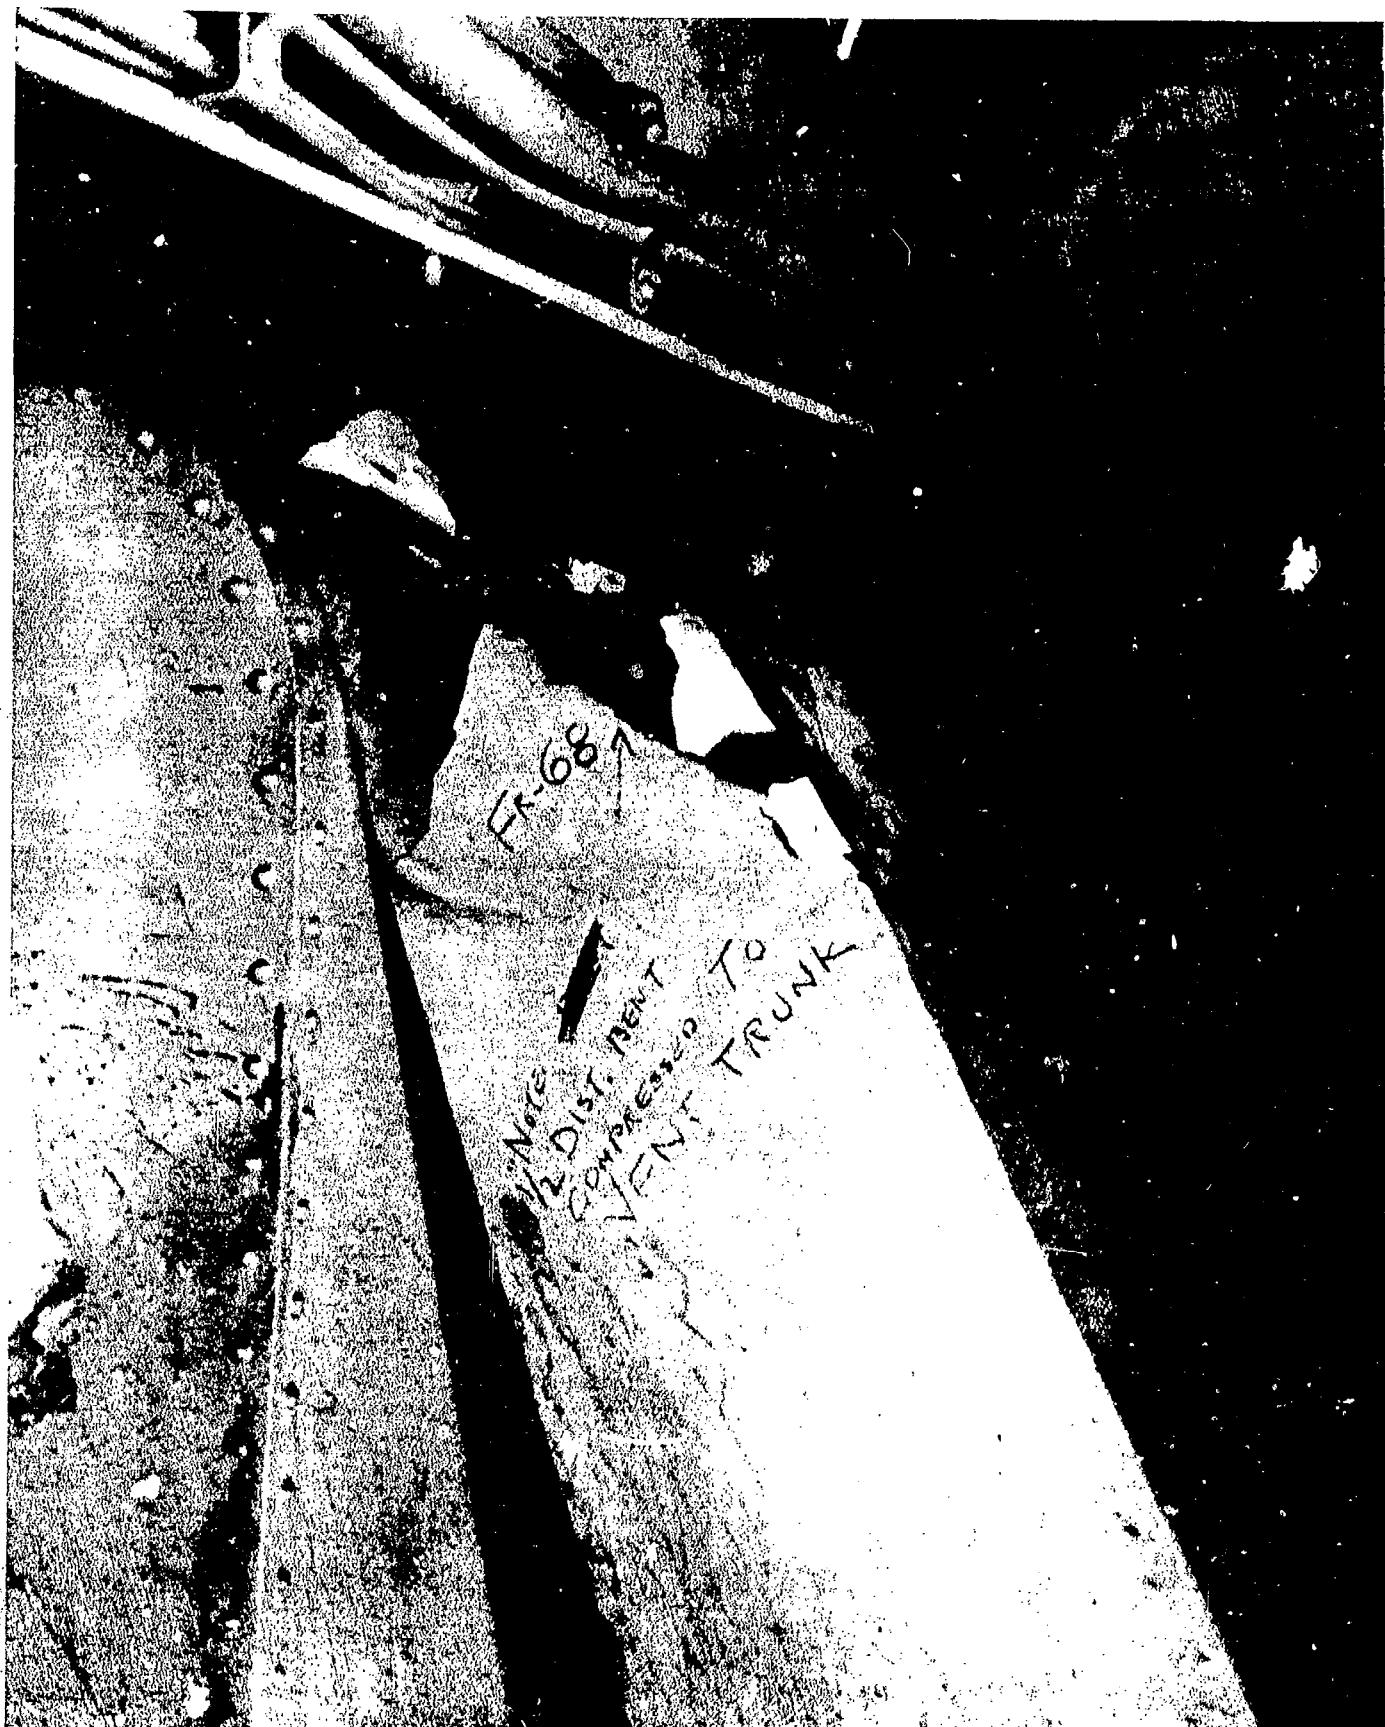
AA-CR-88-2098-1. C-2011. Looking forward and to starboard at distortion of vent duct caused by deflection of transverse frame 68, starboard, under main deck.

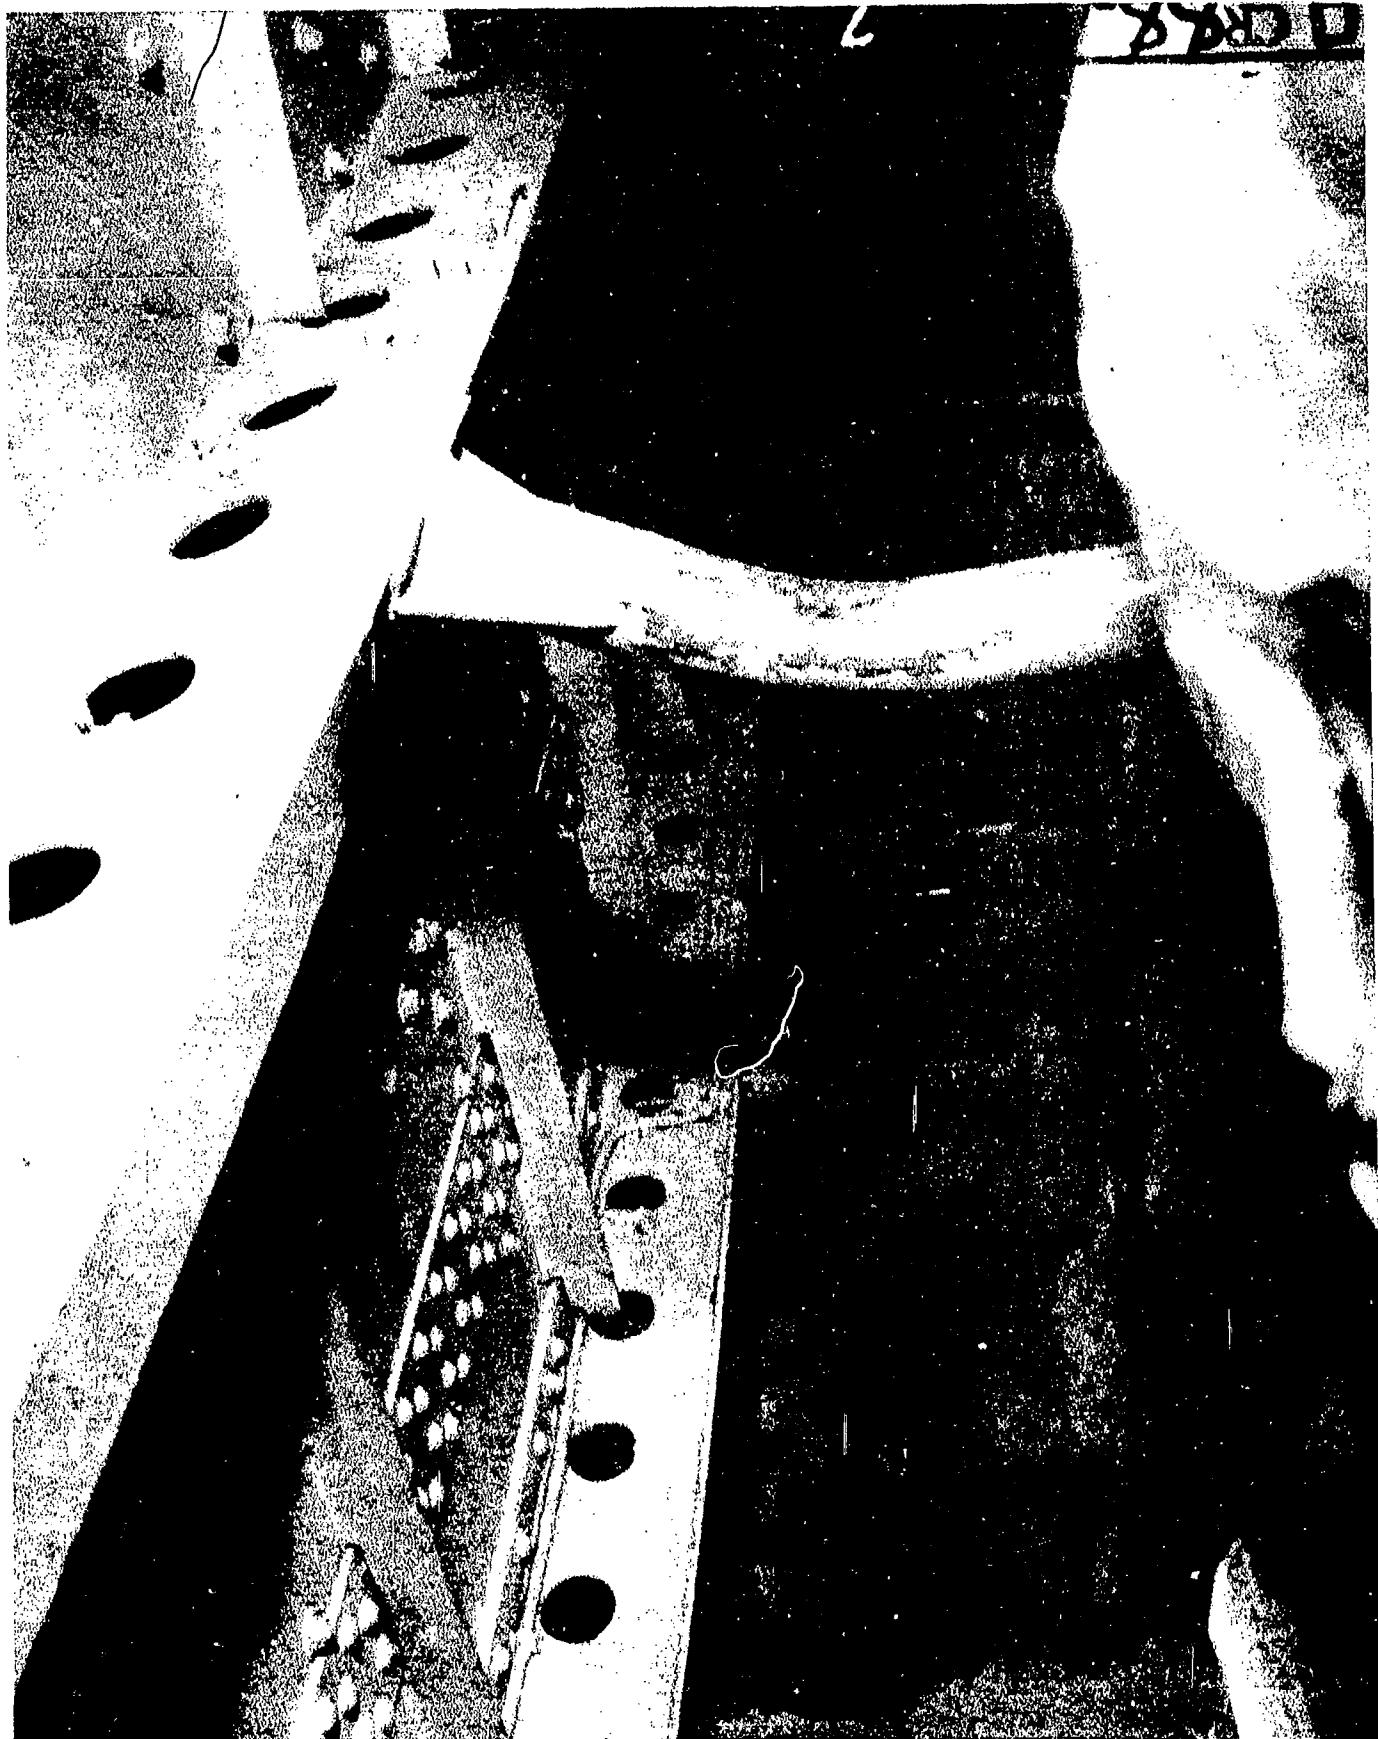
AA-CR-88-2085-7. D-204L. Looking forward and to port at deflected support system under main deck in vicinity of frame 137, port.

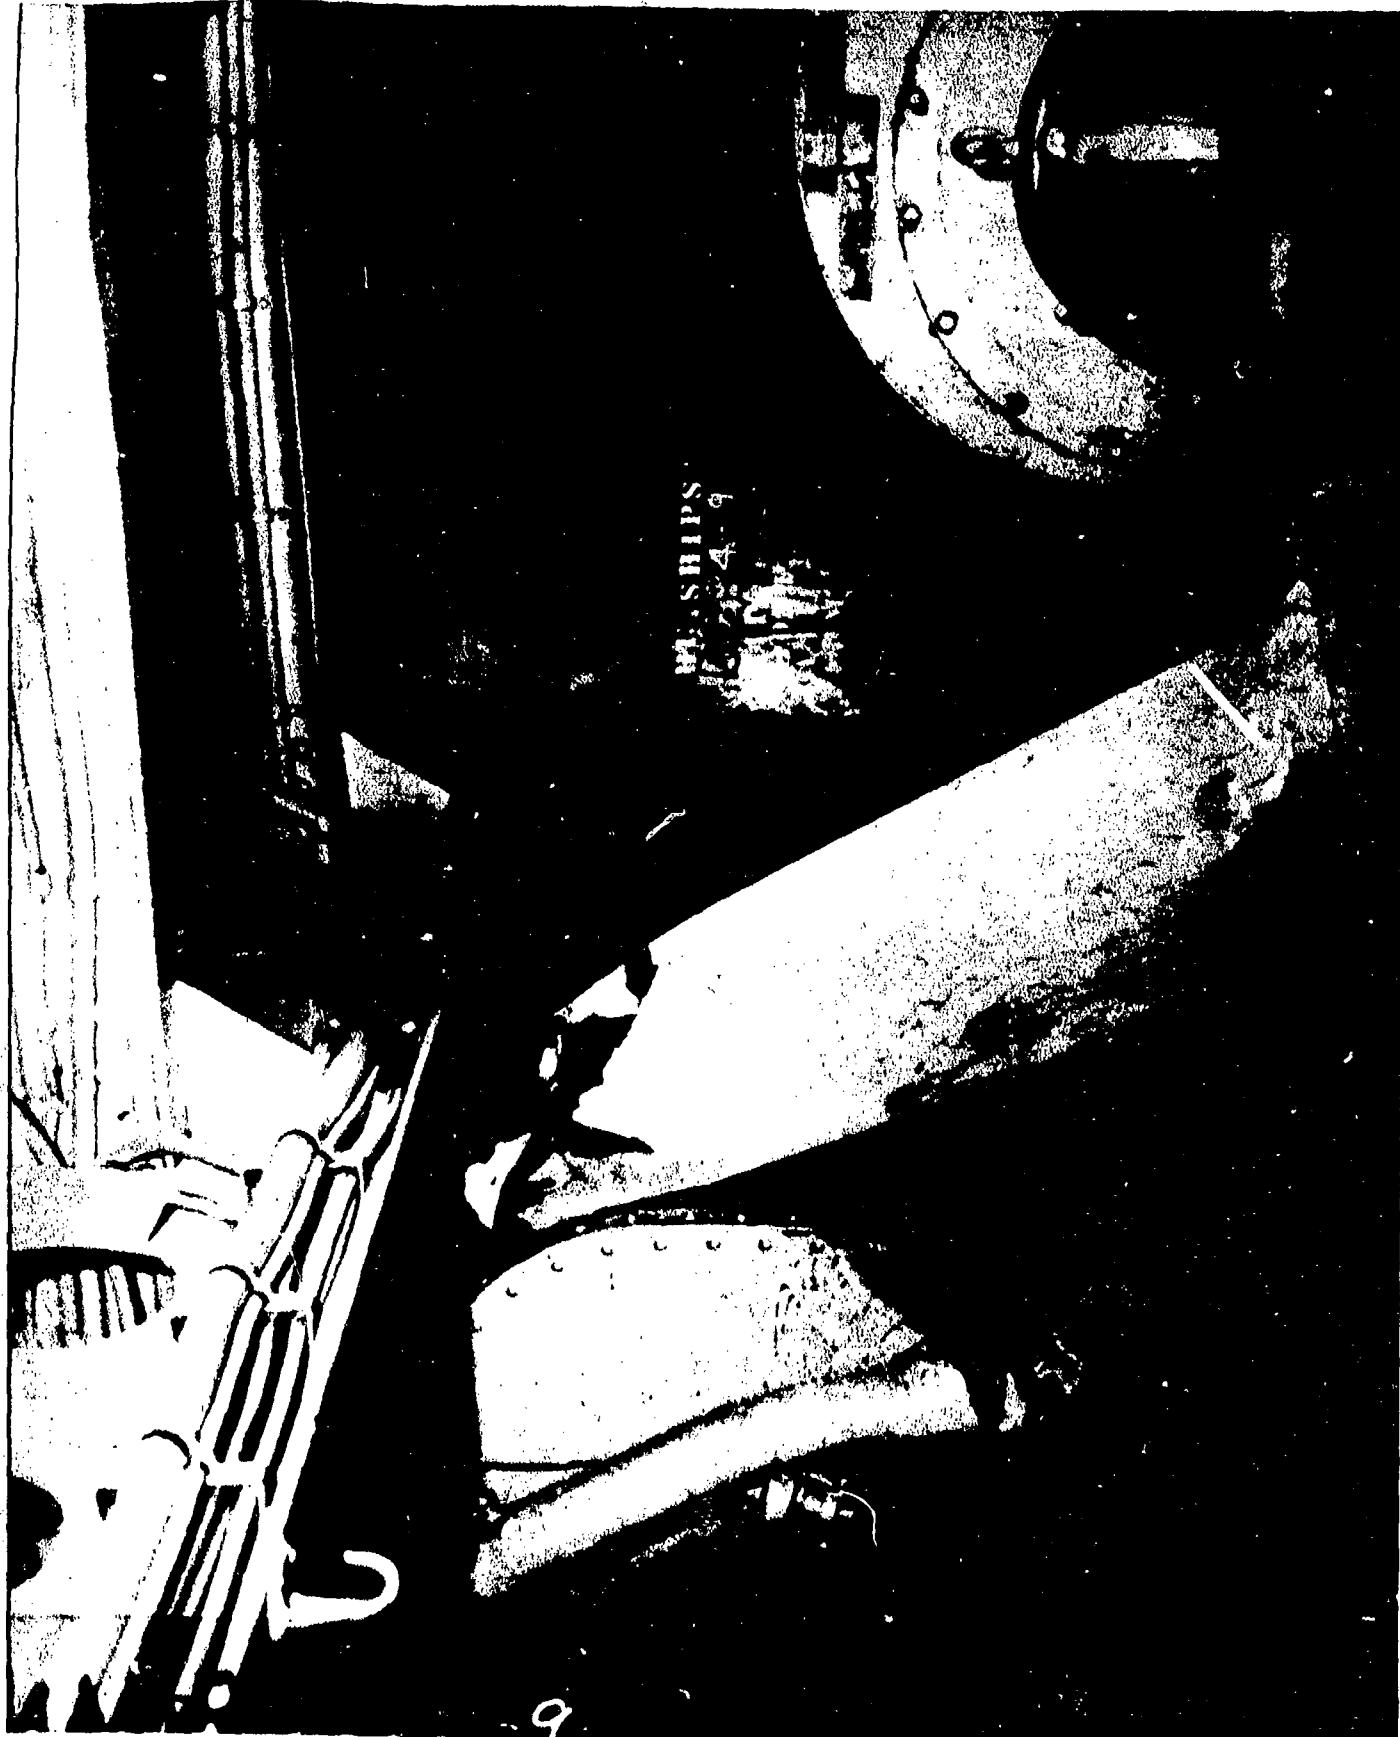
AA-CR-80-1894-9. C-201L. Vent duct crushed by deflected main deck girder, frame 08, starboard.

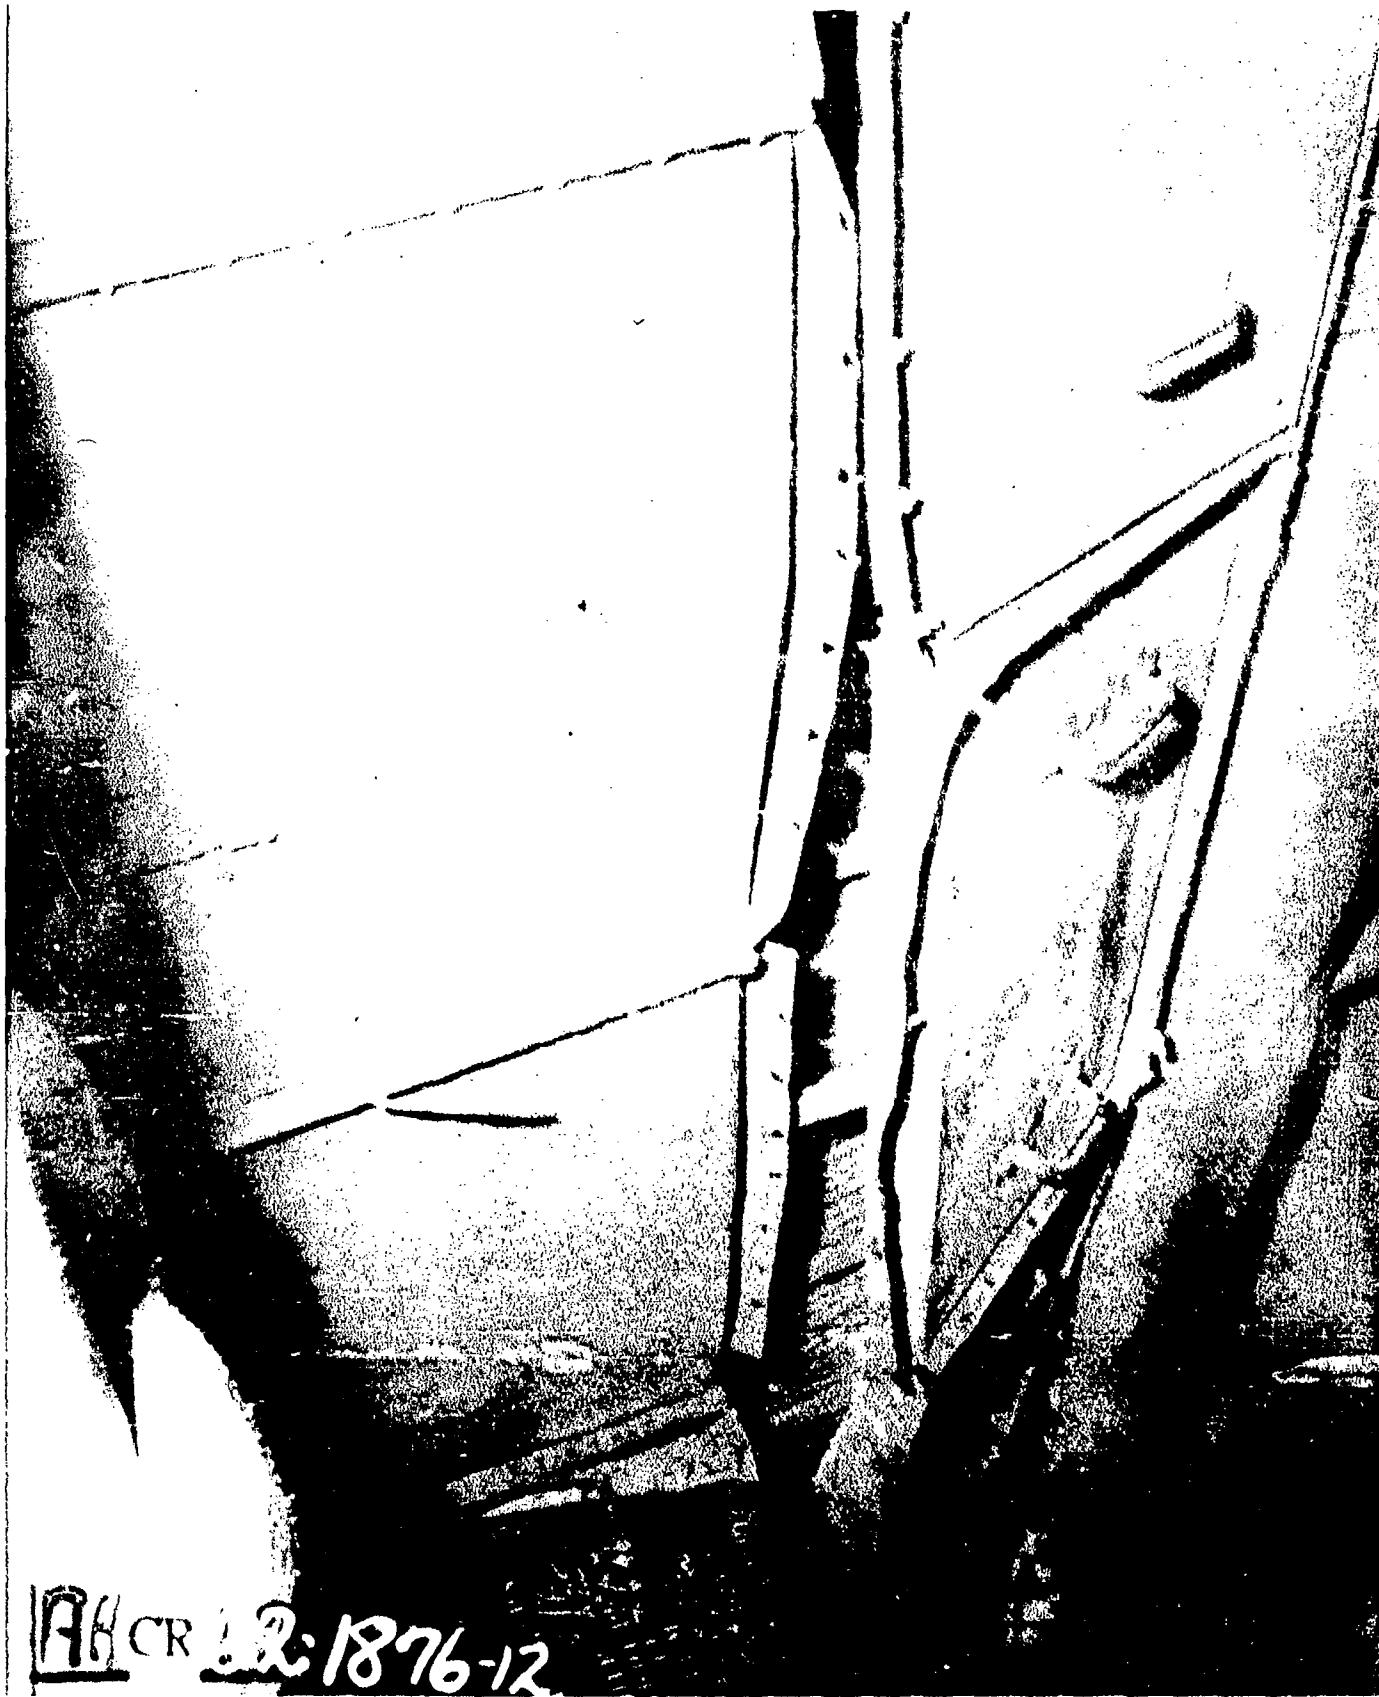
AA-CR-62-1876-12

AA-CR-62-1876-12. No. 1 boiler, outboard side casing.

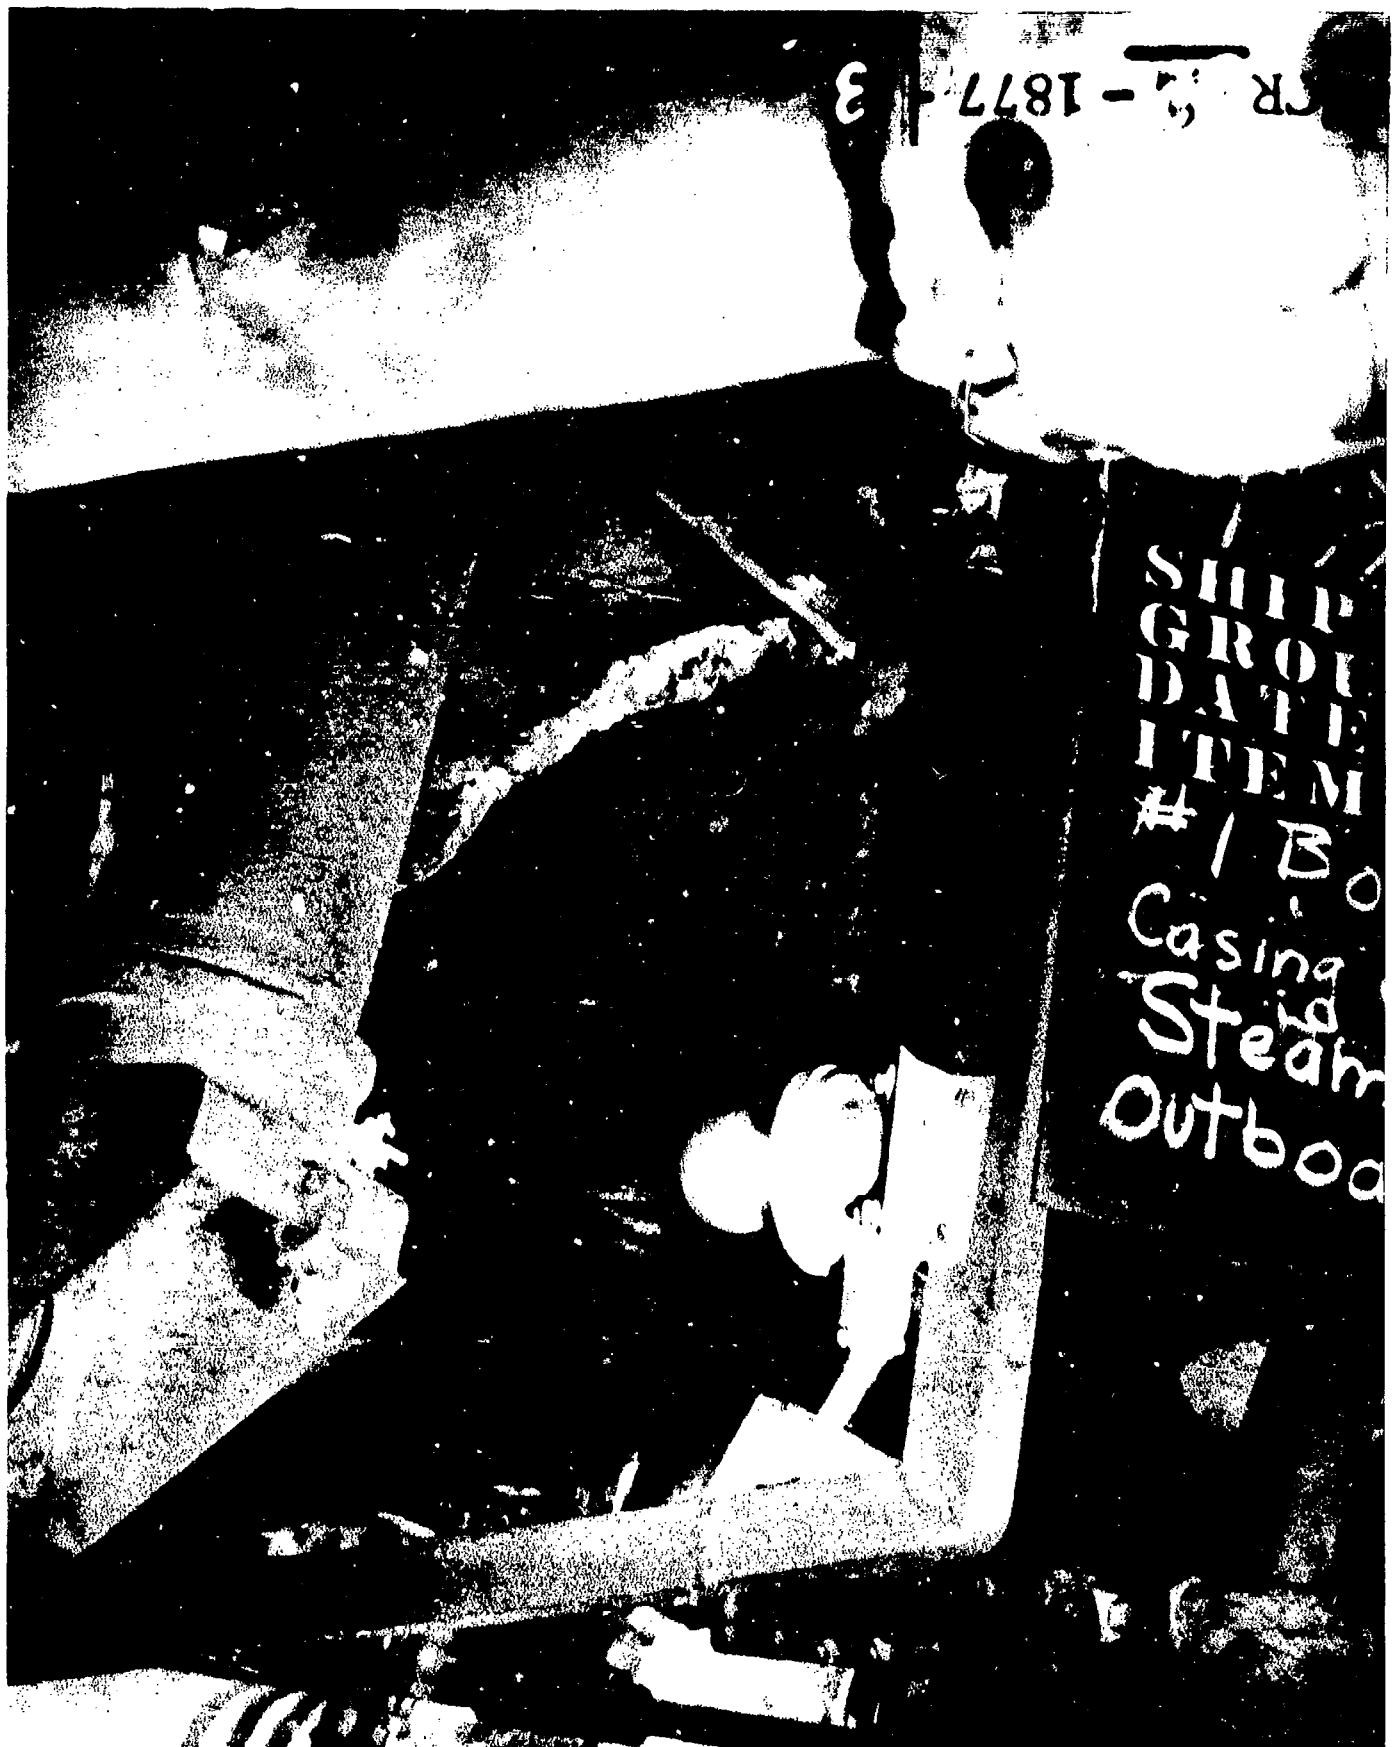
AA-CR-62-1877-3. No. 1 boiler casing at steam drum, outboard side, front.

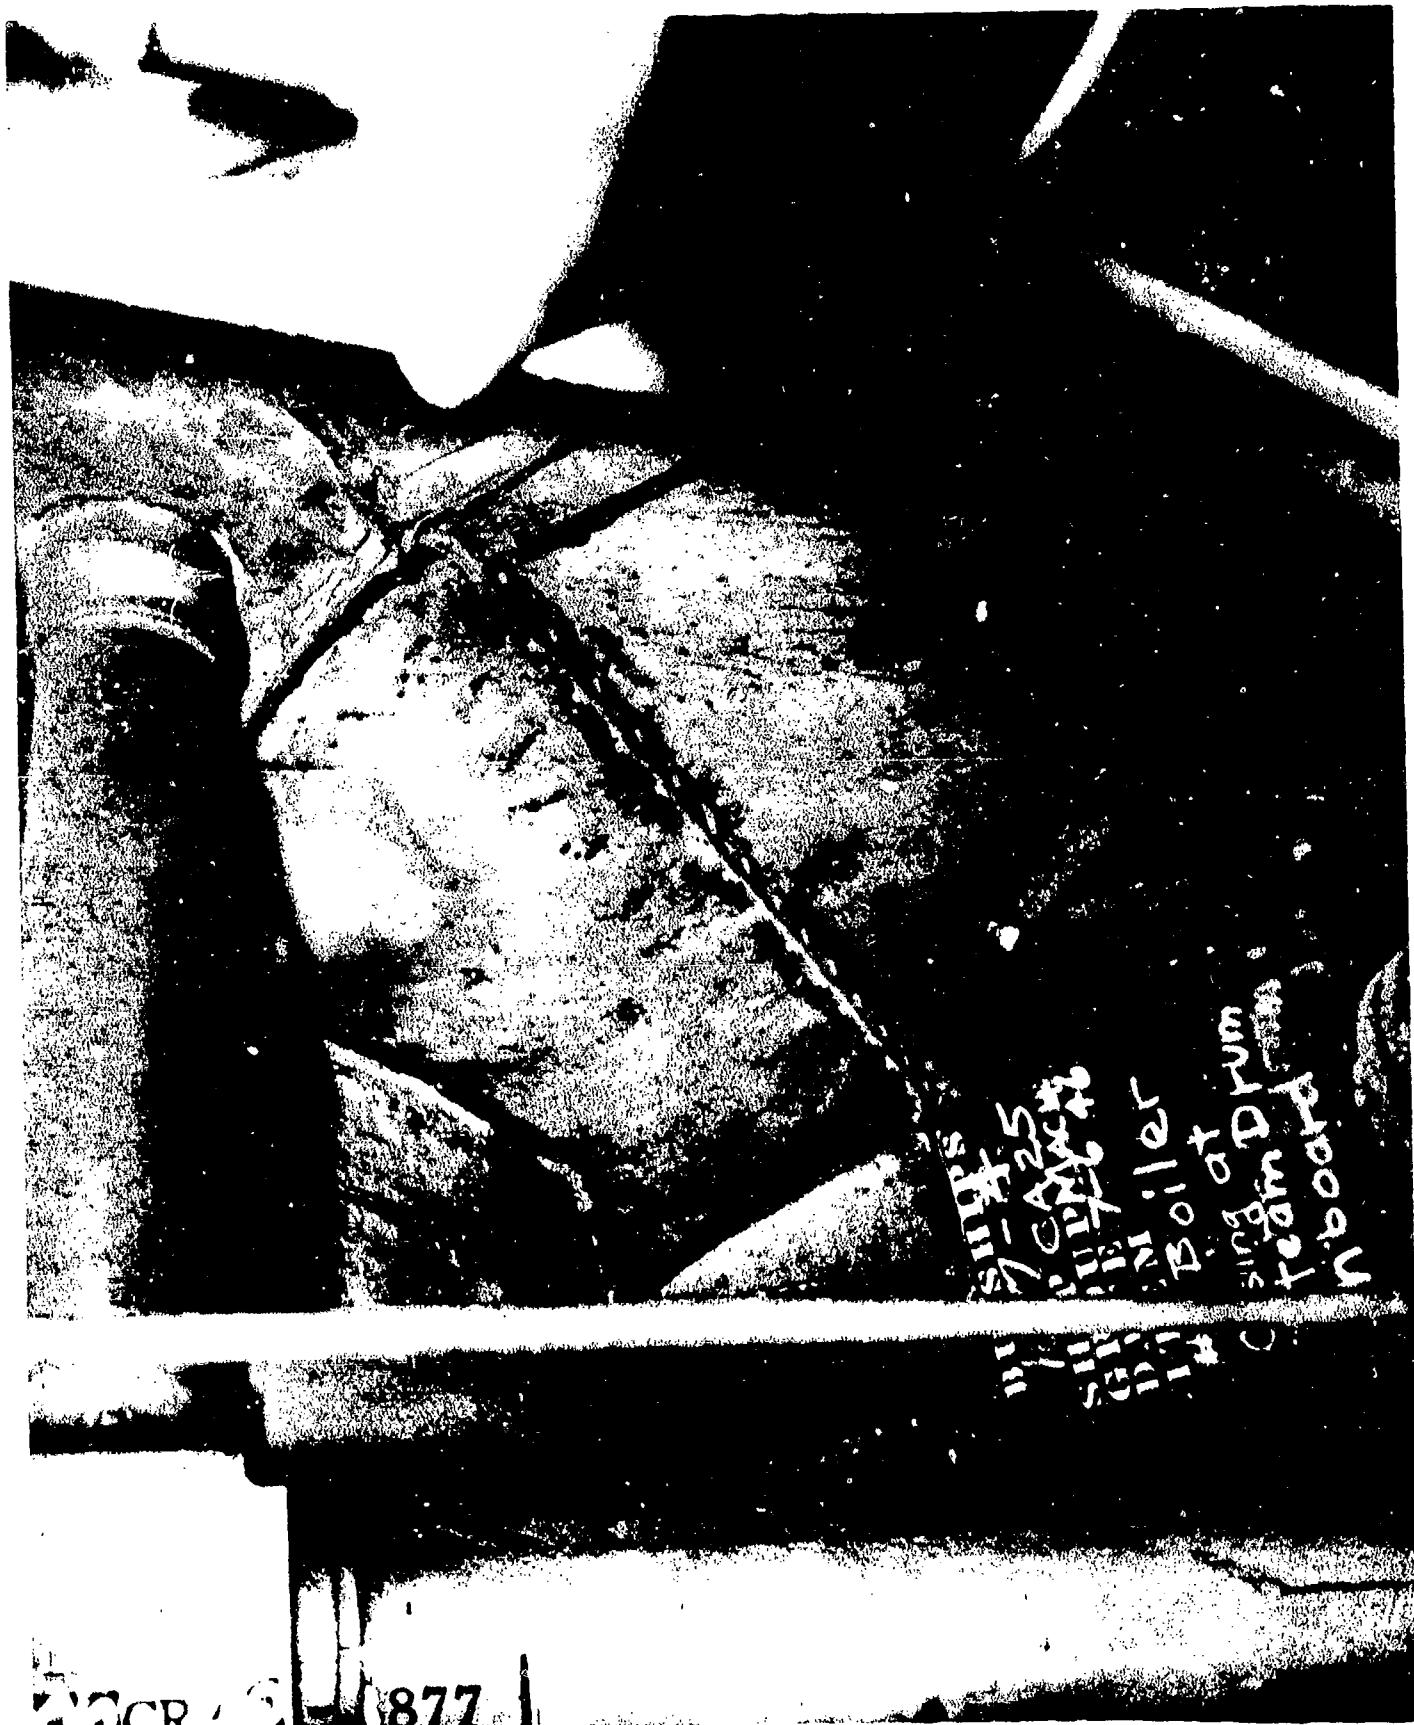
AA-CR-62-1877-4

AA-CR-62-1877-4. No. 1 boiler casing at steam drum, inboard side, front.

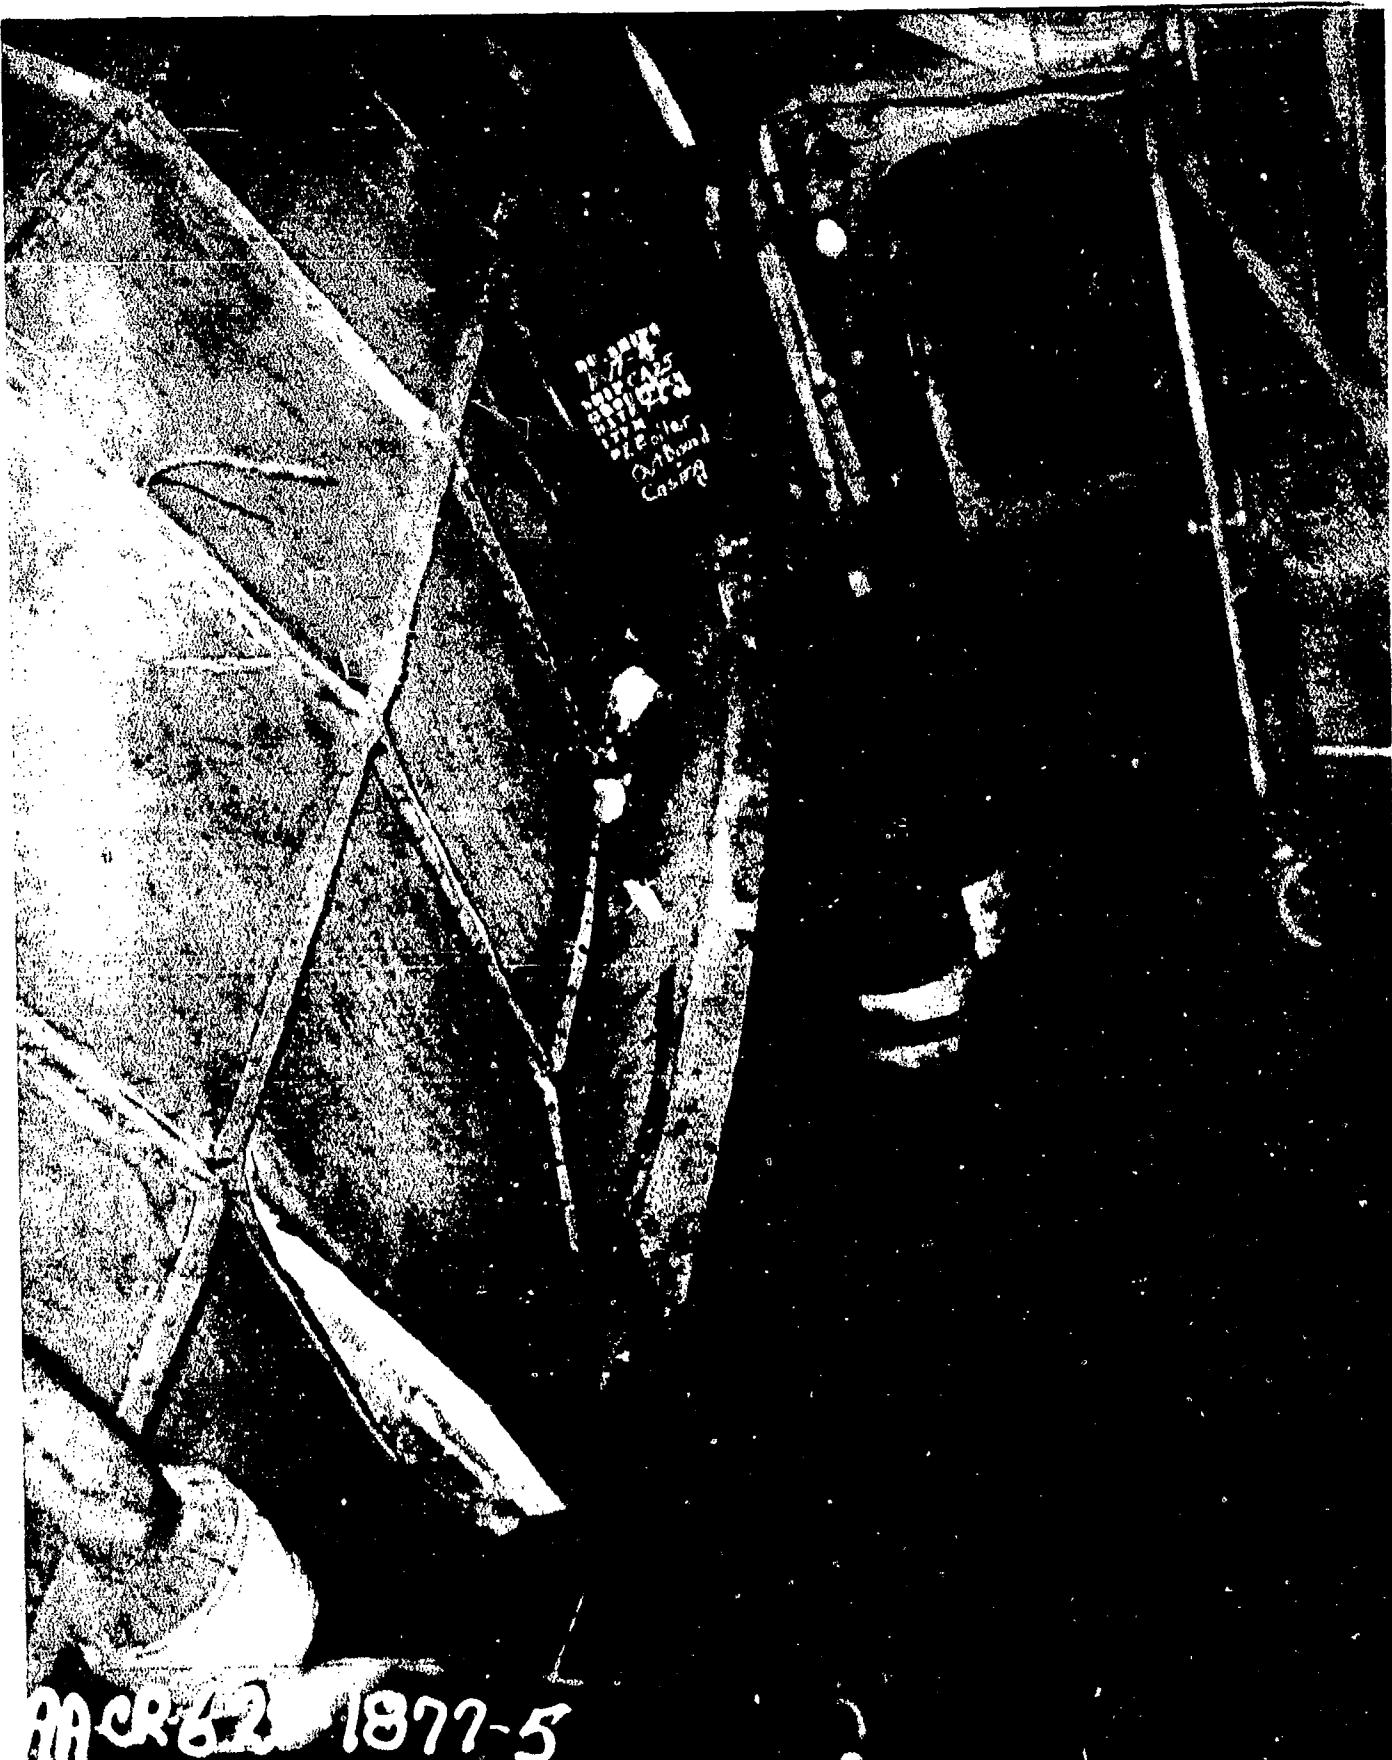
AA-CR-62-1877-5

AA-CR-62-1877-5. No. 2 boiler, outboard casing.

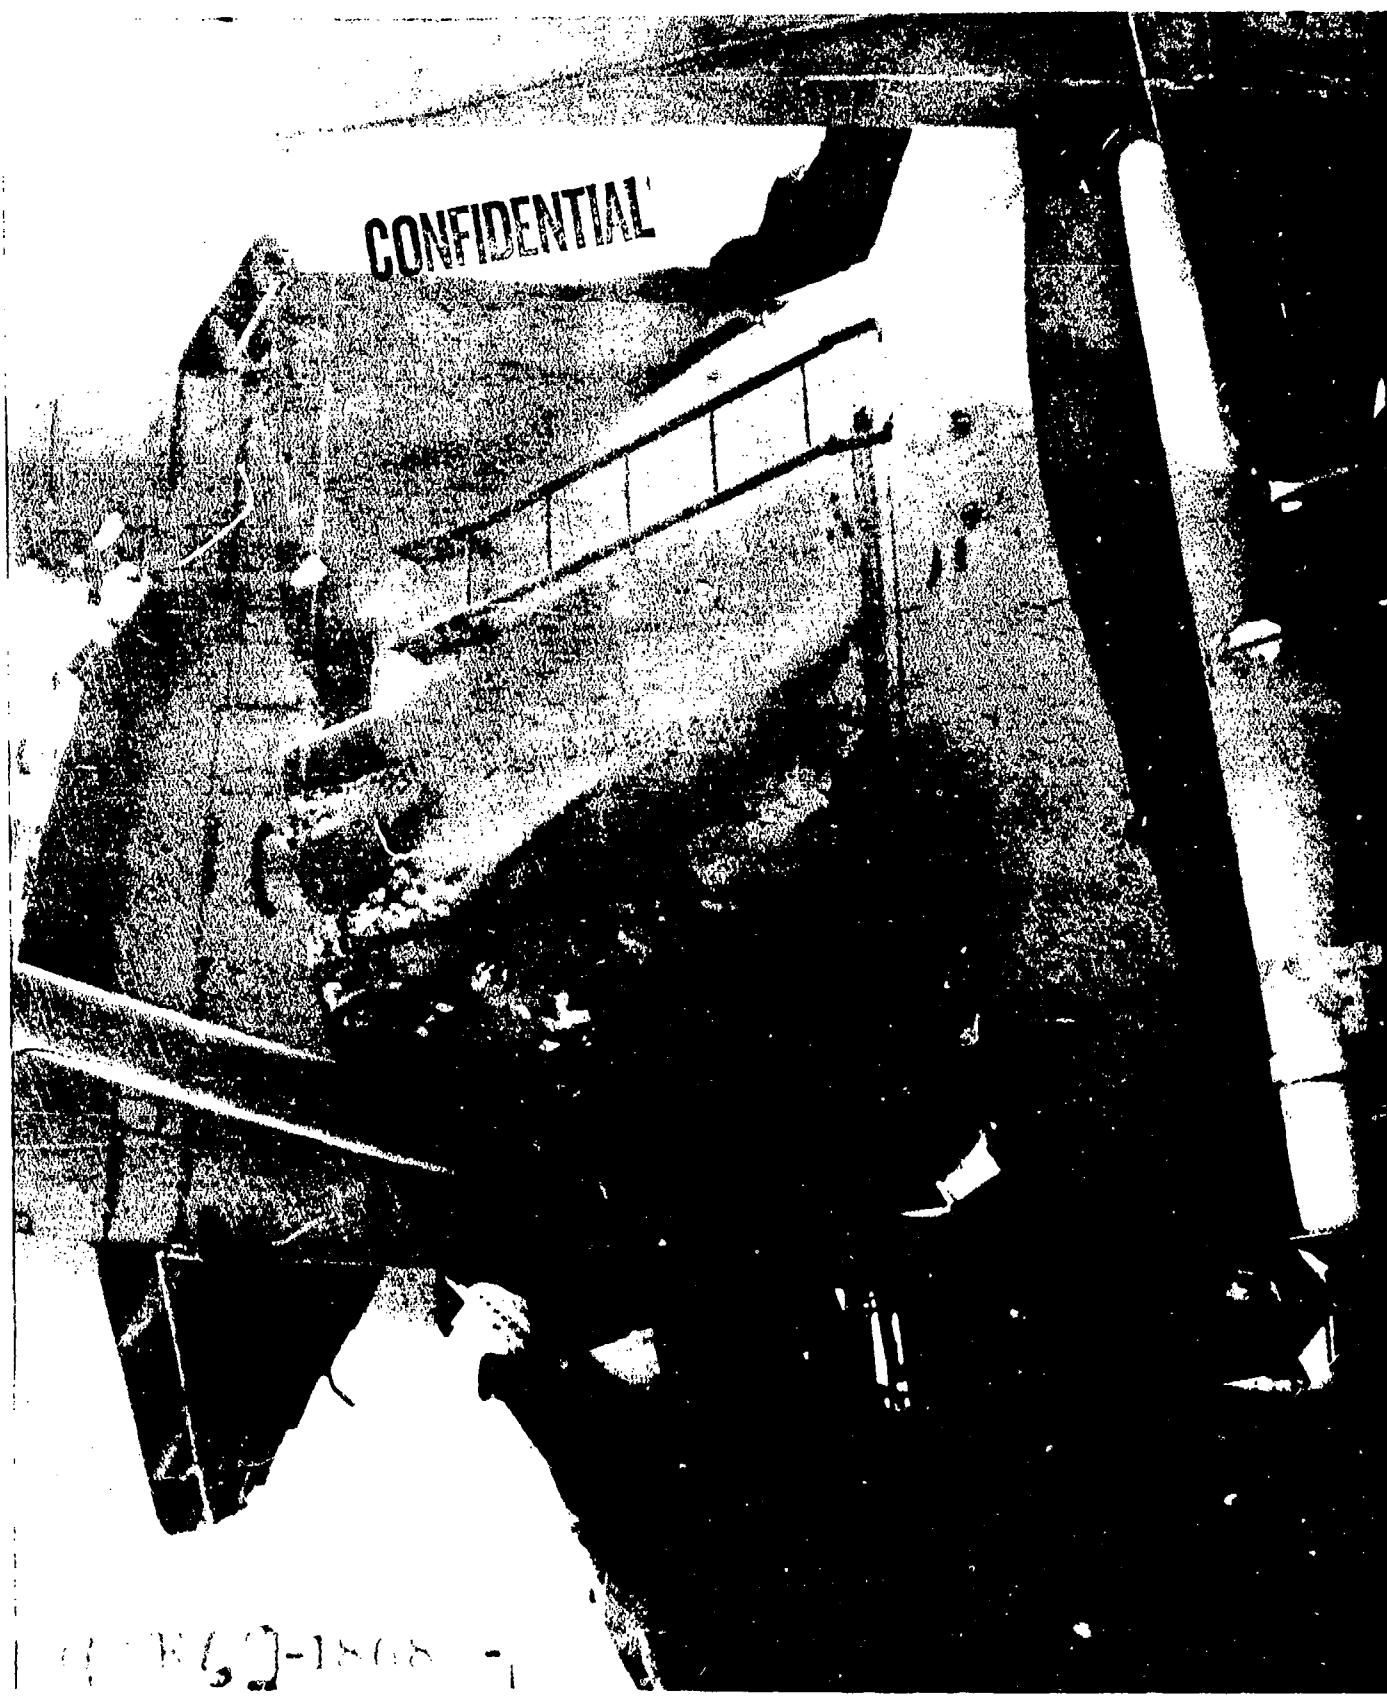
AA-CR-62-1868-11. Looking at No. 2 stack against starboard leg of airplane boom tripod.
